## HOTEL BUILDING RELIABILITY TOWARDS BUILDING AGE

**Abstract:** Mahara Hotel is a tourism-supporting facility and infrastructure first established in Central Aceh District in 1999. This 3-story hotel used a reinforced concrete frame structure, and as time goes by, the service capacity of the building would decrease. This condition was suspected to affect quality and user convenience. Anticipate the older age of the building, and better maintenance management is applied so that the proper building's function can be maintained. The purpose of this study was to assess the reliability of 20 year-established hotel buildings. The method was a descriptive analysis. Data were analyzed based on the guidelines of Technical Procedures for Guidelines for Certificate of Eligibility for Functions (SLF) of Buildings Regulation of Minister of Public Works No. 25/PRT/M/2007. Based on the results, the reliability value of the Mahara Hotel building was unreliable (66.75 %), less than the SLF guidelines (at least 75 %). Some components that caused a low level of reliability to include utility and fire protection components (20.34 %) and accessibility components (3.11 %). The effective and efficient

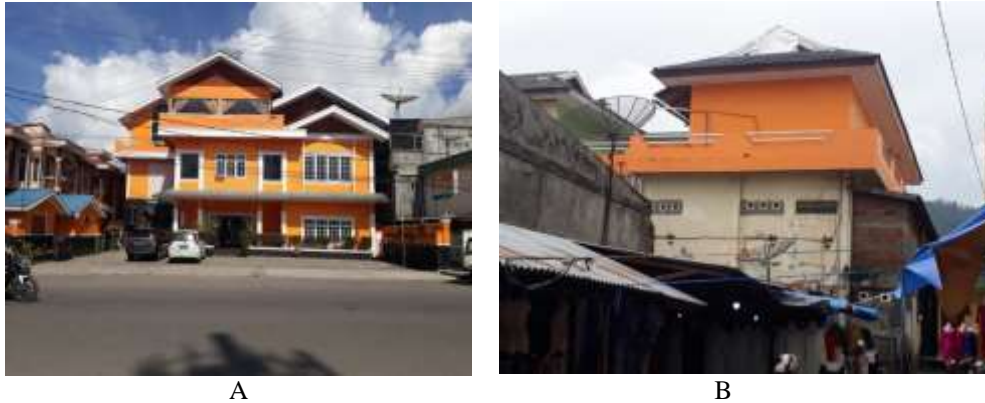
The result of Mahara Hotel building architectural reliability analysis was **96.59 %** and concluded as a **reliable** architectural category according to the specified reliability value requirements of 95 to 100 %.

Figure 2. A. Overall architectural reliability condition. B. Architectural damage conditions

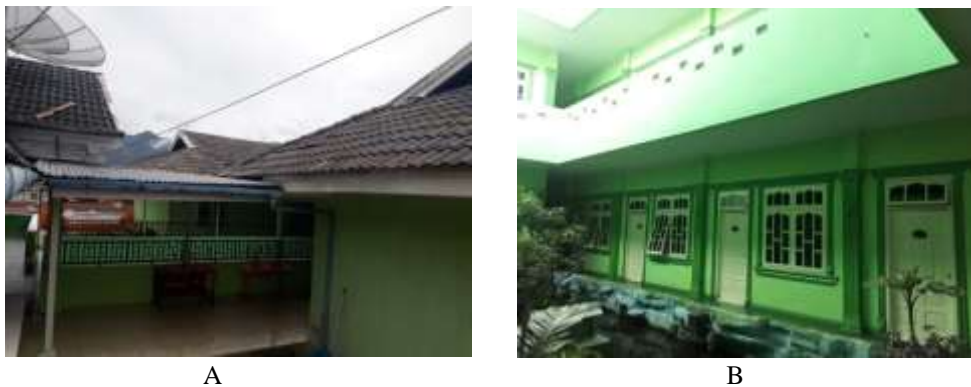
The resulting utility and fire protection components reliability calculation of the Mahara Hotel building was **40.68 %**, concluded as an **unreliable** category since the value was less than 85 % according to the specified reliability value requirements.

**Figure 3.** Condition of utility and fire protection. A. Lack of lightning protection facilities.  
B. Lack of fire-fighting sprinkler facilities

The value of each component reliability of Mahara Hotel building can be used as an indicator of whether Mahara Hotel building management needs to be followed up to improve aspects of each component, which does not meet the requirement of building reliability. This case especially in the elements of utility and fire protection and accessibility. Although the results of Mahara Hotel building, structural reliability assessment were categorized as **reliable (94.13 %)**, however, it is necessary to maintain and repair some parts of the structure. Based on crack data that occurs in several parts of the beam structure of the 2<sup>nd</sup>-floor meeting room, repairment should be done immediately. Several repairment methods, i.e., crack epoxy injection and Carbon Fiber Reinforcement Polymer (CFRP), can be utilized as an alternative (Antonius et al., 2009; Budio et al.). However, this type of improvement is only for restoring the initial conditions, not for changing or increasing the strength of the structure itself.

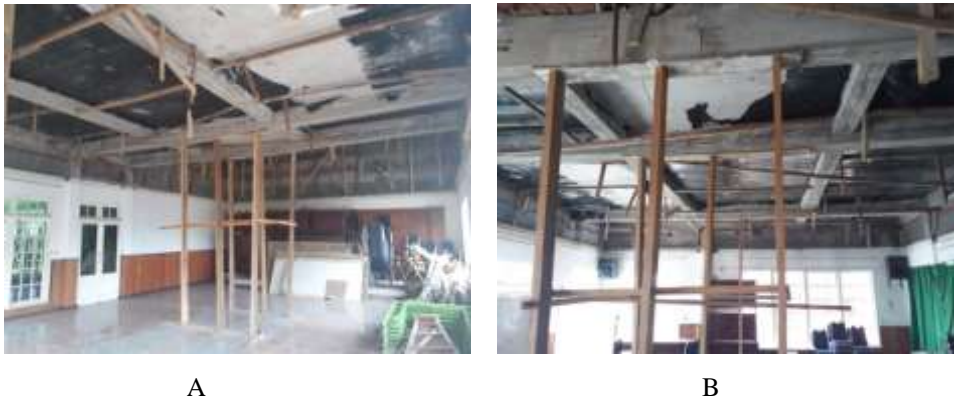
The results of Mahara Hotel building structural reliability analysis was **95.45 %**, concluded in a **reliable** category according to the specified architectural reliability values of 95 to 100 %.

**Figure 4.** Structural reliability condition A and B. Damage is in the beam components located in the hotel conference room (deflection and cracking).
